**UTAH
DEPARTMENT OF
AGRICULTURE
AND FOOD**

State Ground-Water Program 1997

**Mark C. Quilter
Agriculture Ground Water Specialist
Environmental Quality Section**

STATE GROUND-WATER PROGRAM REPORT 1997

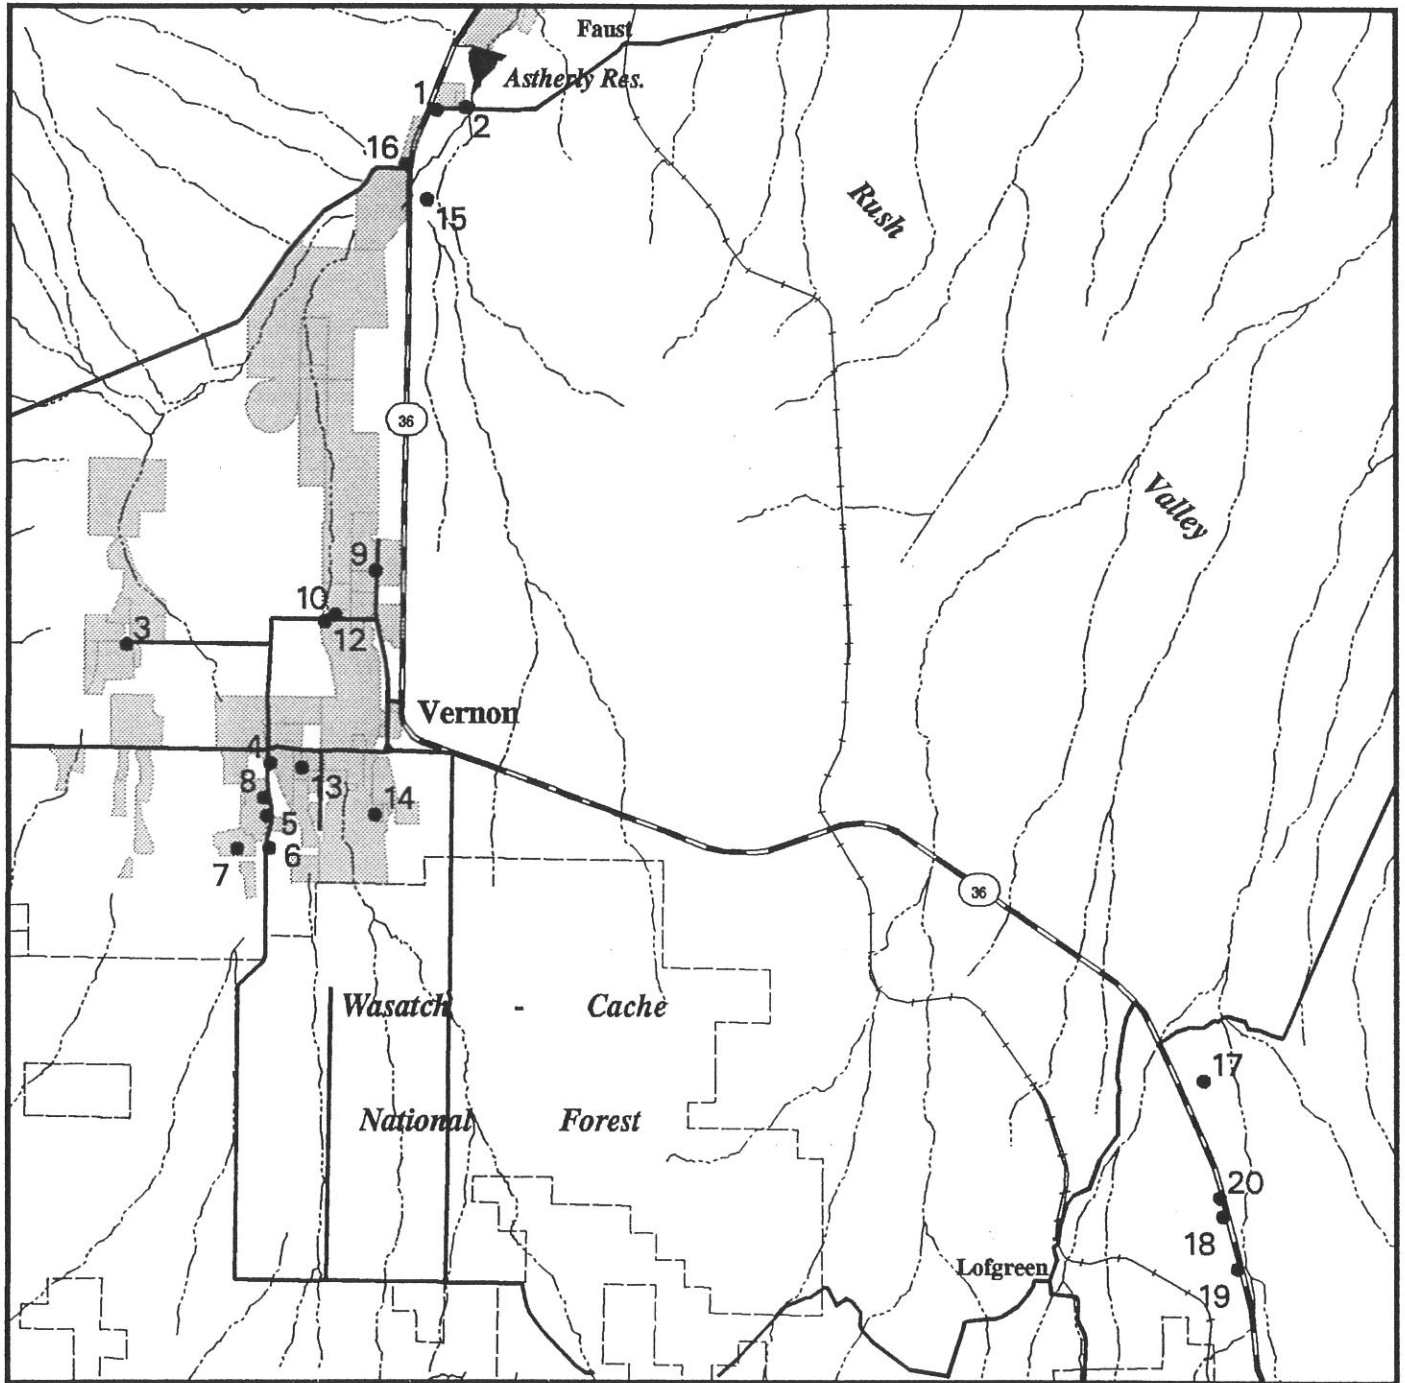
Vernon Area, Tooele County, Utah

1997 UDAF Ground Water Sampling Locations

Map Scale 1:114,000 (1 inch = 1.8 miles)

Under the direction of the Shambip SCD 20 wells were sampled in the Vernon area of Tooele County on May 6, 1997. These wells are used for irrigation, culinary purposes, and livestock. Generally this water is well suited for irrigation and no serious problems were found. The chemical analyses are listed on Tables 2a and 2b. The map shows the location of all sample sites

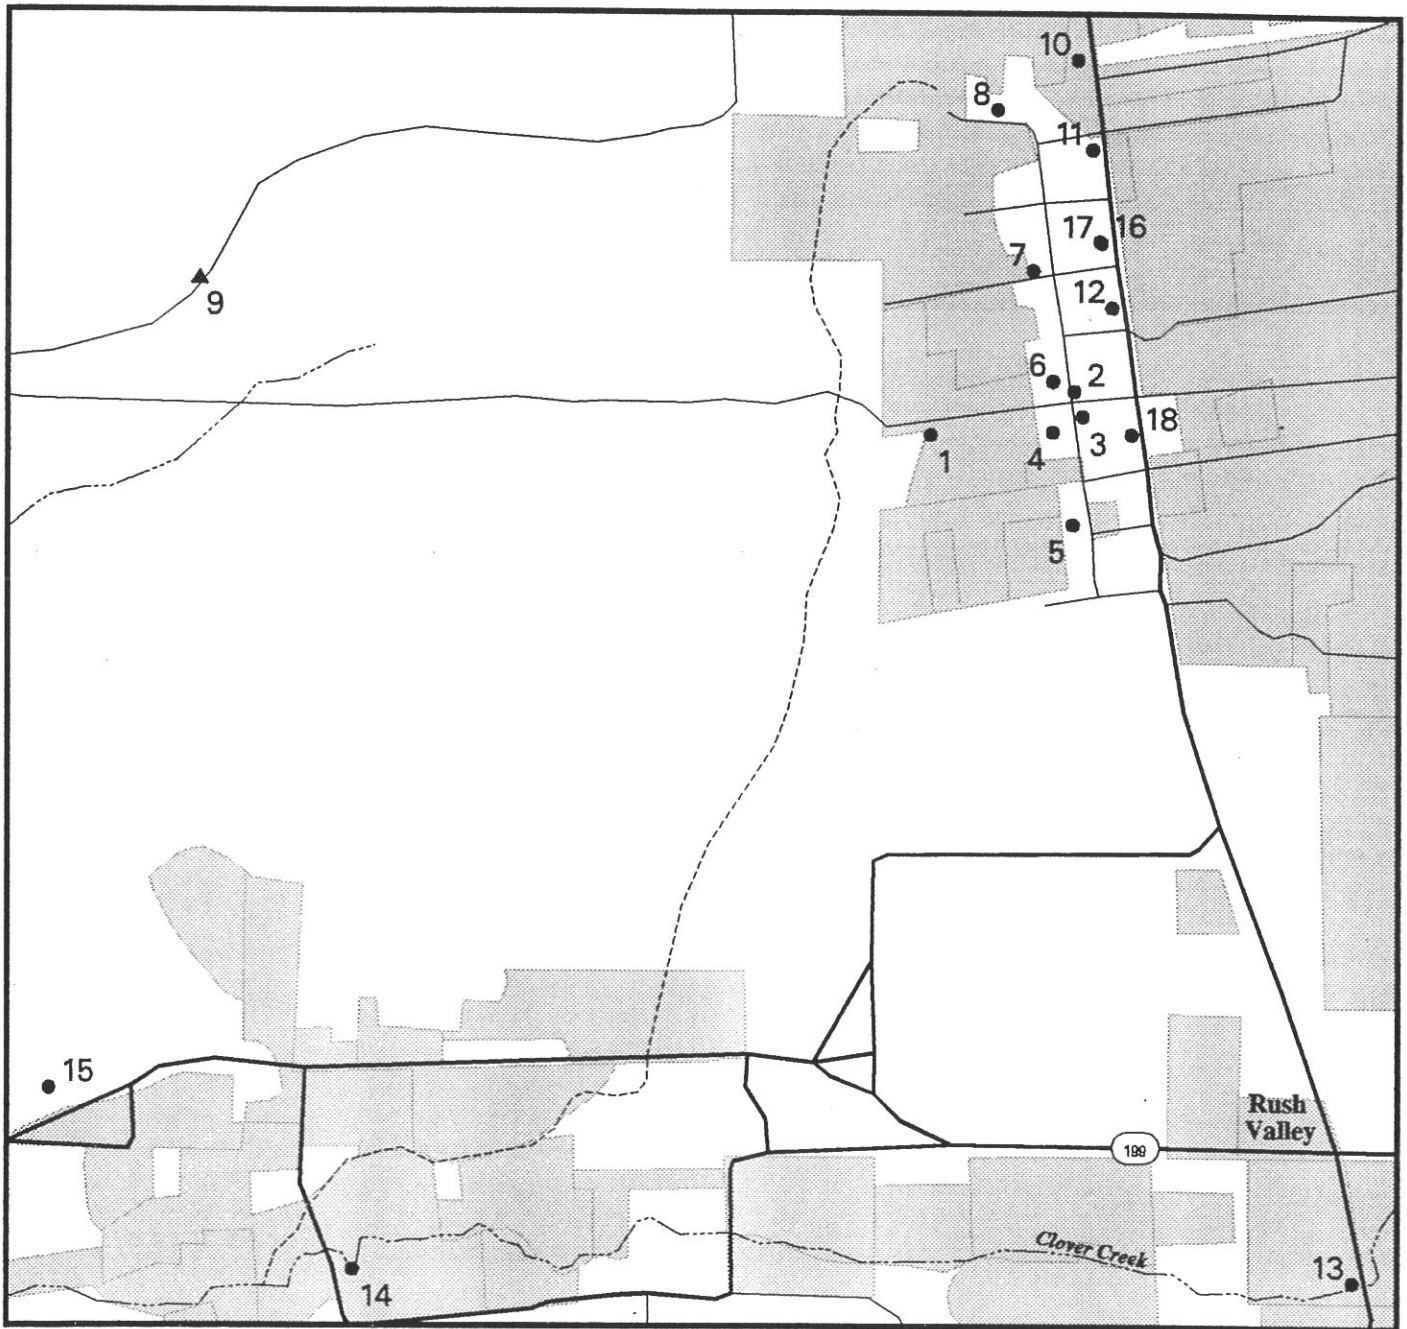
Clover Area, Tooele County, Utah

1997 UDAF Ground Water Sampling Locations

Map Scale 1:20,000 (1 inch = .32 miles)

Under the direction of the Shambip SCD18 wells were sampled in the Clover area of Tooele County on May 21, 1997. These wells are used for irrigation, culinary purposes, and livestock. The chemical analyses are listed on Tables 3a and 3b. The map shows the location of all sample sites
